# Understanding Historic Parks and Gardens in Buckinghamshire

The Buckinghamshire Gardens Trust Research & Recording Project

## Dorton Spa

October 2019

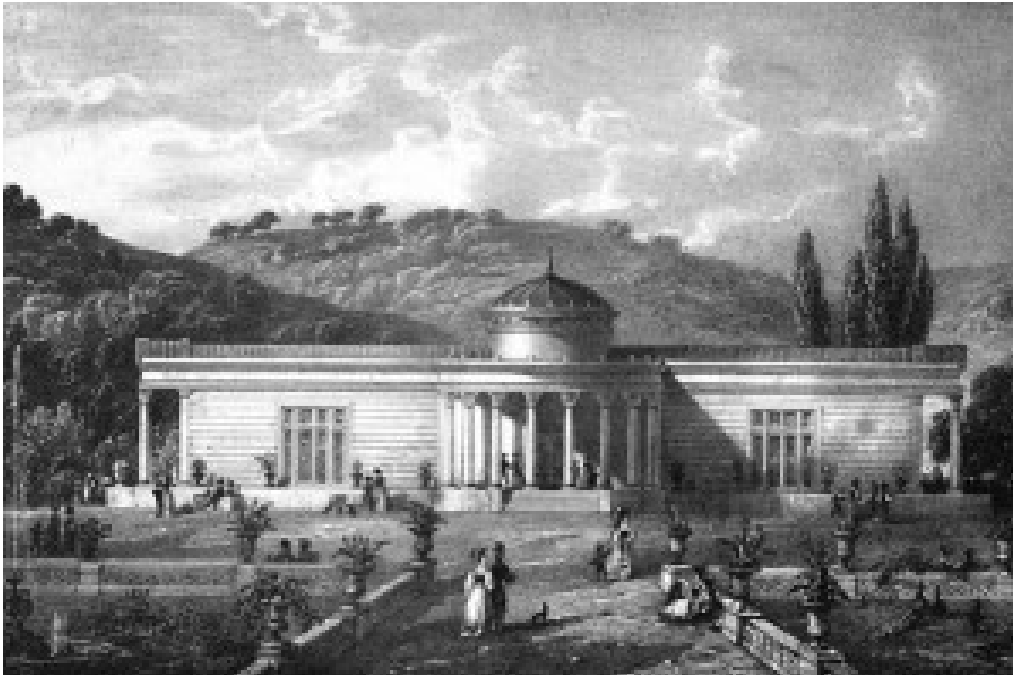
The Dorton Spa building as designed by Hakewill in 1833 (Knight)

Thomas Knight published *The History of Dorton Chalybeate* in 1833 (also 1835 edn) with stories of cures, illustrated with a plan and an elevation of an extensive building in Greek Classical style, 'erecting from the design of Mr James Hakewill'. Hakewill (1778-1843) was an architectural draughtsman from a family of architects and was chiefly known for his architectural publications. His few executed designs include the Greek Doric lodge at Tatton Park, Cheshire (1833-4), and the pump room at Dorton Spa (1834). In 1835 he submitted a design for the rebuilding of the Houses of Parliament in a C16 style based on Longleat House and Hatfield House (*ODNB* James Hakewill).

The building as illustrated by Knight was never fully realised, the Ballroom, Reading and Billiard Rooms on either side being omitted along with their colonnaded exteriors. A contemporary article showed the truncated building (*The Mirror of Literature, Amusement and Instruction*, August 31, 1839, see front cover). There was a grand fete at the Spa, and another in 1837 at the coronation of Queen Victoria (Wikipedia and Geri Walton). Without these extra rooms the building's half round columned portico led to a reduced pump room and through further columns only to suites of bath rooms and accommodation for attendants. The 2nd edition of the *Dorton Guide* regrets that 'the Ball and the Reading Rooms attached to the Baths cannot now be added' (article in *The Times*, 18 August 1856: HER).

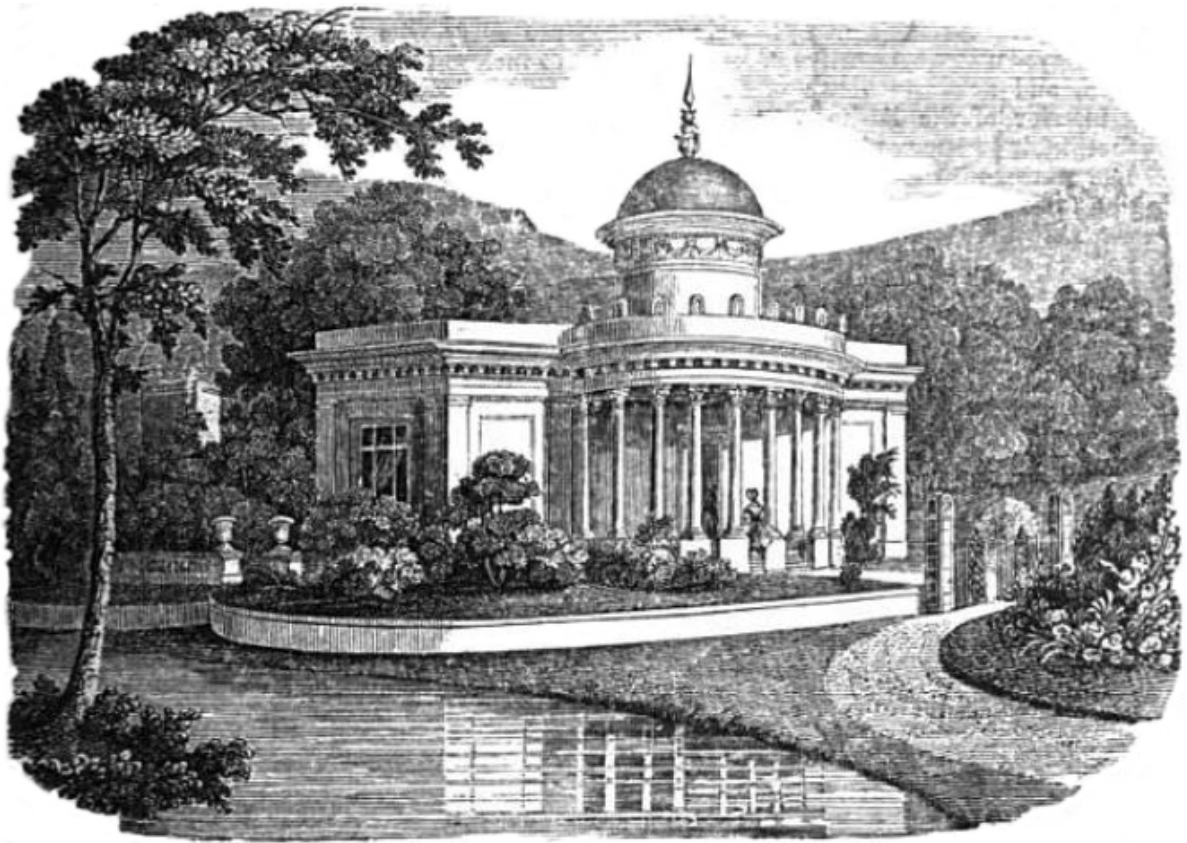
The completed, and truncated, spa building next to the boating pond with highly manicured grounds.

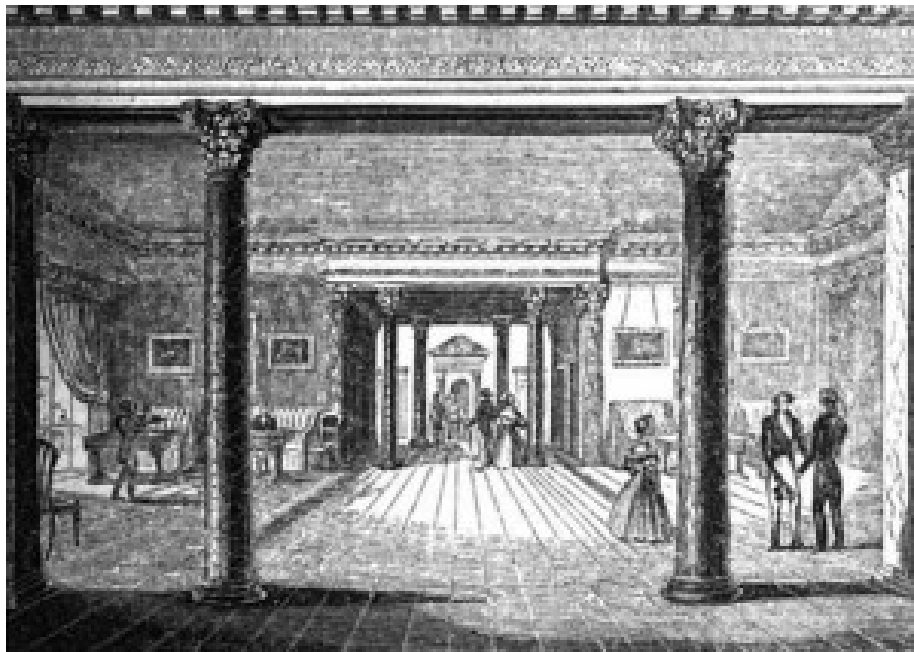
The interior

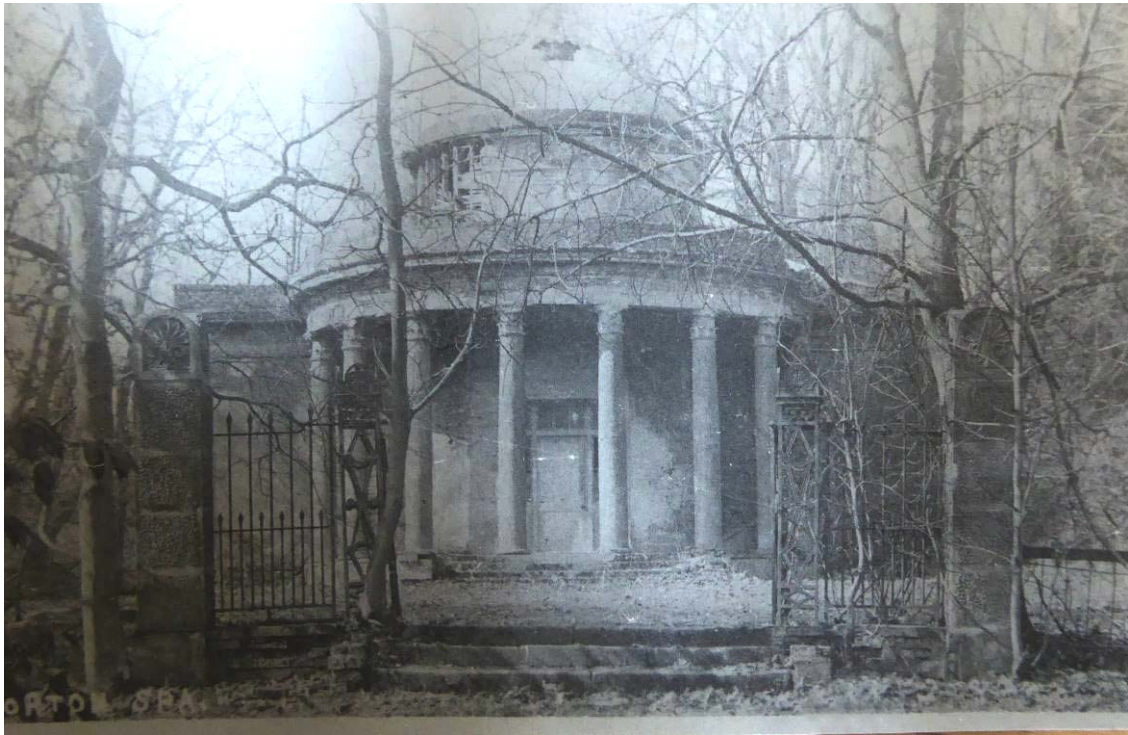
Photograph in dereliction, 1906, Centre for Bucks Studies (CBS photo D215-1-3).

The Spa building was demolished c.1906 and survives only as footings. The central portion was in classical Greek style. It comprised a single-storey rectangular building enlivened by a semi-circular columned projecting portico topped by a dome on a drum. The surviving remains show that the building and its columns were built of red brick and were rendered and detailed with stucco. By c.1906 shortly before its demolition (photo CBS D215-1-3) a photograph shows that the drum supporting the dome was constructed of rendered timber.

Entrance elevation of the spa Building taken through the frontage gates and steps c1906 (CBS photo D215-1-3)

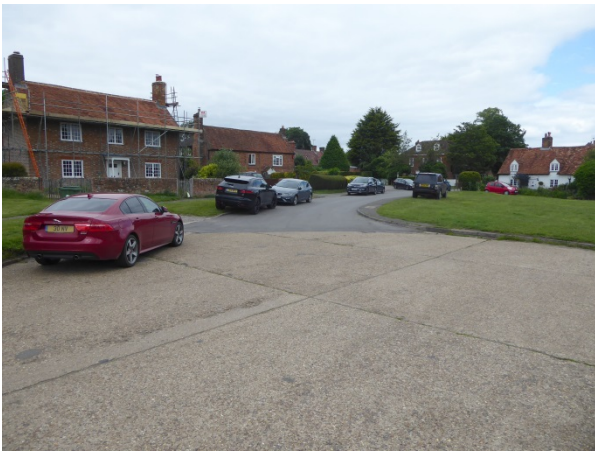
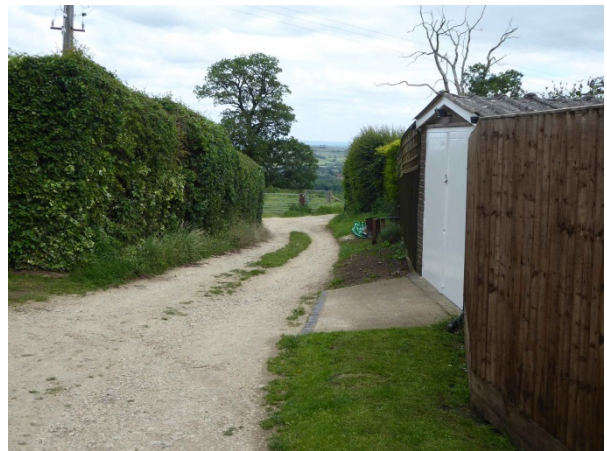
The Green, Brill looking north east (left); The track as it leaves the modern estate built over the first part of the original approach (right)

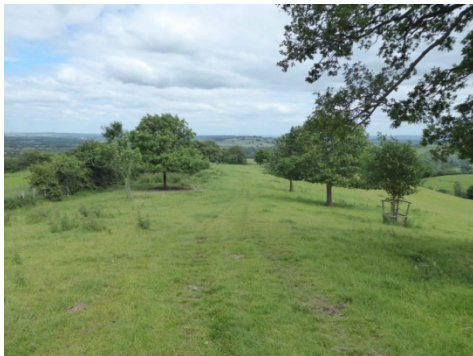
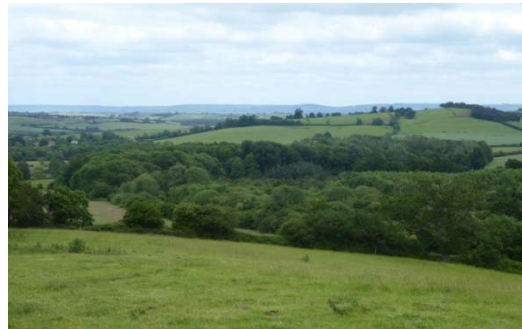
The approach running east from Brill (left); The first view of Spa Wood from approach (in middle distance) (right)

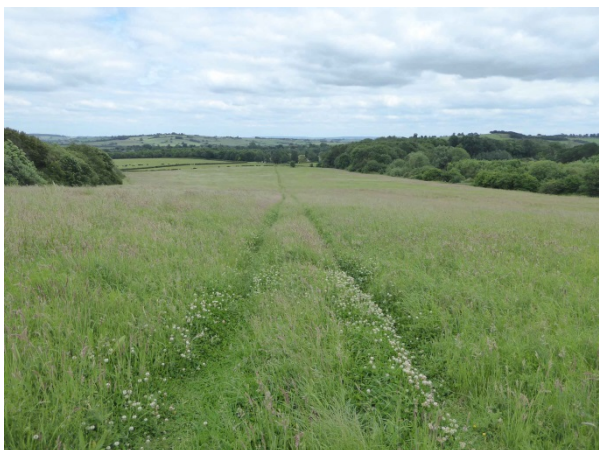
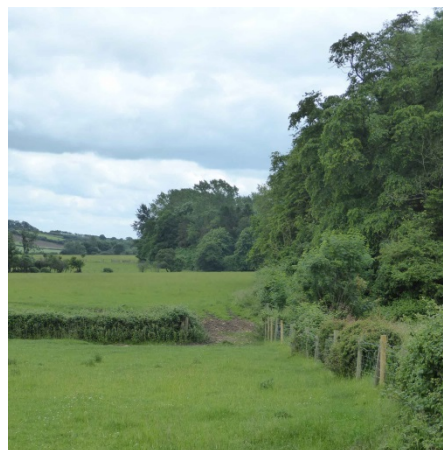
The view towards Spa Wood from the final field traversed by the approach (left); the approach down the east side of Spa Wood (right)

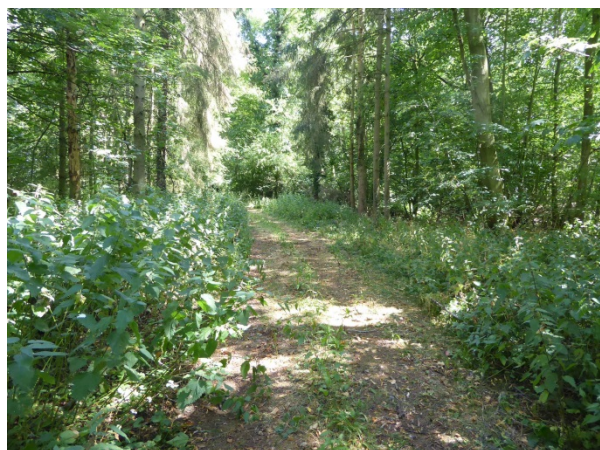
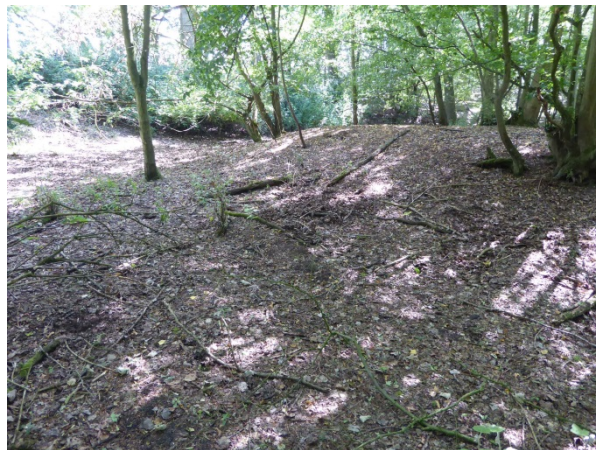
Access is from the drive of Spa Farm and across a field (across private land by kind permission of the owners) running south-west to the south-east extremity of the Wood, rather than formerly when the Spa was in operation from Brill via the entrance avenue down the east side of the northern portion. The woodland track follows the route of the track noted on the c.1878 OS. Immediately to the south the extensive boating lake survives, its depression c.5ft deep

and clearer from vegetation at its outer (south eastern) end than at the centre, dry at the time of the visit for this report although it can be 'impassably boggy' at other times: P.Gulland, pers. comm.). The track curves slowly to the north through mixed planting of various ages. The ground is level on the northern side of the track but falls noticeably away towards the northern boundary of this half of the wood.

The woodland track in the southern portion of Spa wood, looking south east (left); the southern portion of the boating lake (right)

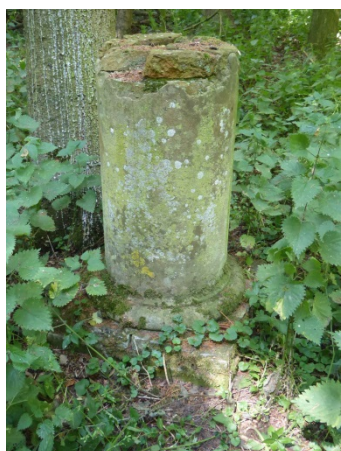
The stumps and bases of two former circular columns (respectively 4ft and 3ft high - 1.2 and 0.9m - with their square bases) stand some 3.5m apart just north of the track about halfway between the site of the Spa building and the south-east entrance. The columns display the standard classical torus (large half-round) moulding at the base. These two relics have been moved from the site of the spa building.

The surviving stumps from the portico of the Spa building left by the side of the southern woodland track (left); the boundary treatments to the west of the original approach (right)

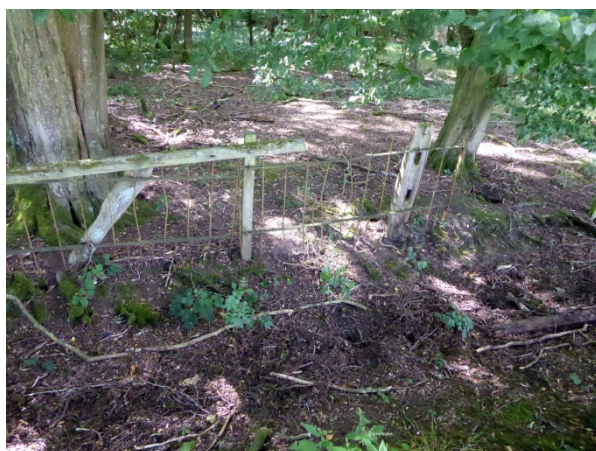
The track continues northwards (150m) along this east boundary which with a ditch displays patchy evidence of three boundary treatments: (a) worn and decayed large timber posts pierced for heavy rails and reused as supports for the other systems; (b) panels of slender round section iron palings with tall spikes. Even slenderer dog bars are in place lower down all set in thin rails; (c) panels of modern timber fencing. Either (a) or (b) could be original to the Spa development. This boundary would have been an important element of the character of the entrance to the Spa, helping to create first impressions among clients. The metal railings (b) have been in place for a considerable time such that the lower third of one panel has become buried. We know that finance must have been tight for the Spa from the failure to complete the intended building, but these metal panels appear too plain and spindly to impress customers. Nevertheless, this metal fencing is visible immediately to the right of the gates in the photo of the spa building shortly before demolition (photo CBS D215-1-3) and must be taken as the original boundary feature. The track continues with its own field boundary on its eastern side until it approaches the north eastern corner of the northern part of the wood and it turns westwards across the wood. Two thirds of the way (90m approx.) across the wood this modern transverse track meets an earlier track that bisects the northern portion. A short distance (40m approx.) south of this junction stands the remains of the lodge/ refreshment room which is located to the west of the north-south track (the spine track in 1878 ran directly to or through it). This building survives only as two brick walls with rendered faces. The spine track continues south (160m approx.) and runs through a game pen across it in the centre of the northern portion of the wood. South of the pen, the track approaches the northern end of the former boating lake and turns to the east to connect with the track in the southern portion. At the bend, wheeled traffic has exposed the south eastern exterior corner of the Spa Building which is a one-and-a-half bricks thick with evidence of an exterior coat of stucco. About 4ft (1.2m) of the southern elevation is exposed across the track. A further approx. 5ft (1.5m) of the eastern front elevation can be explored by the side of the track running up and ending with a thicker pier. The bend in the track also drops down, roughly in line with the line of the former gate and steps leading to the Spa building from the original entrance.

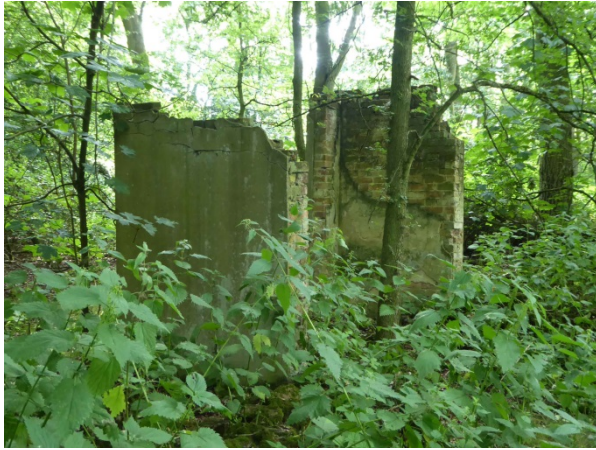
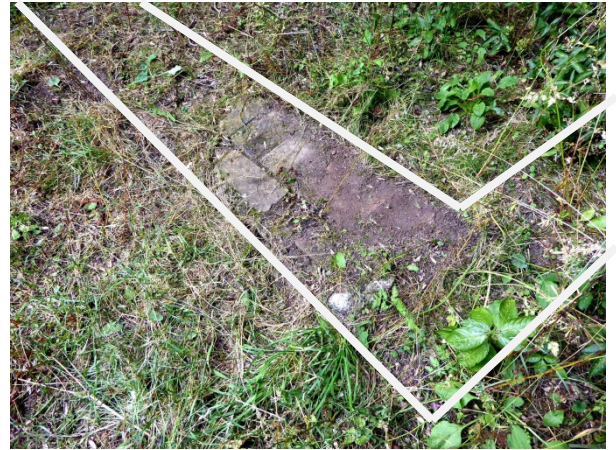
A track branches north eastwards towards the original entrance to the wood as the track approaches the central waist of the wood. It passes the piers and gates of the forecourt to the Spa building to the east, where meagre red brick foundations are still in place, probably evidence of the former piers and railings evident in the CBS photo and the August 1839 view of the Spa building. Various trees in the vicinity have strange bases as if they have commenced growing around masonry features. These elements are roughly in line with the original eastern boundary of the pleasure grounds of the Spa. This arrangement can be clearly seen by 1920 (OS), by which time the Spa building had disappeared and the former lake was indicated as a marshy expanse.

The ruins of the lodge/refreshment room from the east (left) the footings of the Spa Building - outside south east corner of building at bottom right (right)

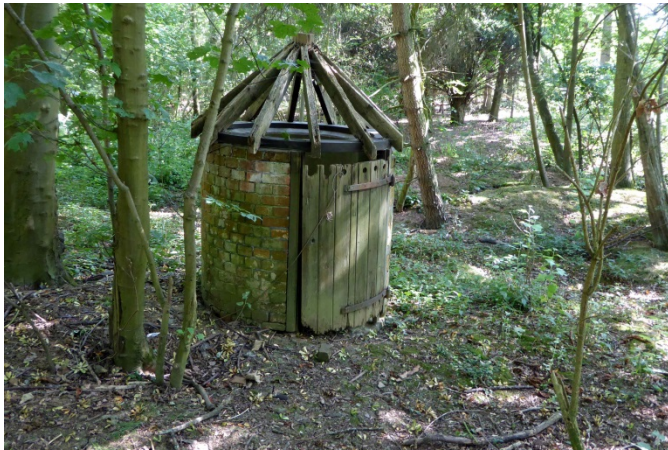
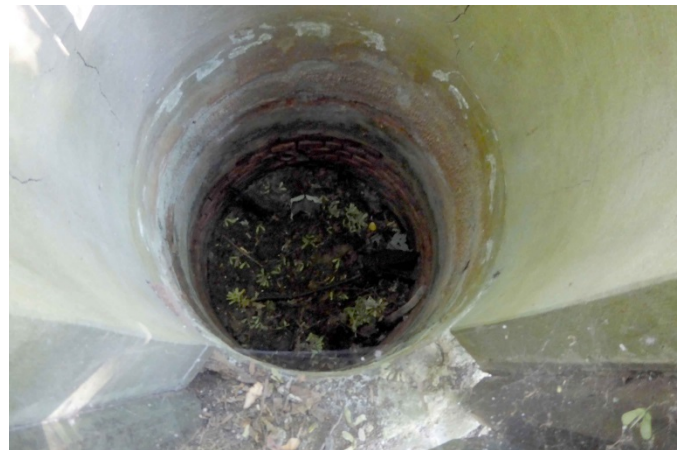
18m approx. south-west of the Spa building was the Chalybeate spring, now marked by a small circular brick enclosure some 5ft (1.5m) tall to the eaves with a timber door. The conical roof was recently restored with clay tiles by the Chilton Estate (Sir Henry Aubrey-Fletcher, pers. comm) but the tiles and laths have since been stolen. The enclosure surrounds a shallow circular well shaft, dry at the time of the visit with no sign of the spring. The enclosure is shown on the first edition OS (1878) as a square building with another, rectangular, structure close by to the north west (possibly a small building with a covered verandah towards the Spa building).

Chalybeate spring building exterior (left) and interior (during a notably dry summer) (right)
